U.S. Department
of Transportation
**Federal Aviation
Administration**

ADVISORY CIRCULAR

43-16A

AVIATION MAINTENANCE ALERTS

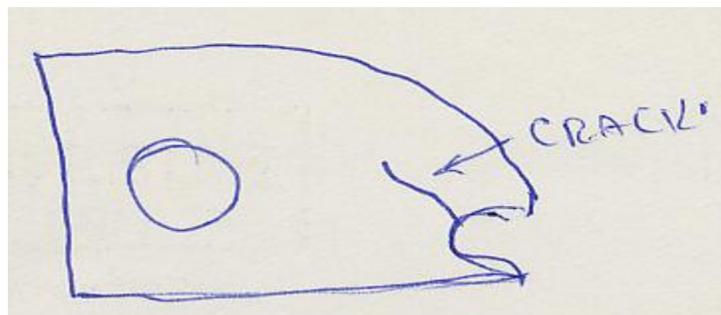
Beech: A36; Cracked Flap Leading Edge Nose Rib; ATA 5753

“At annual inspection, (we) found both the left and right flap attach point ribs cracked.” (An additional note indicates both the flange and web on these parts were cracked or broken. Flap Nose Rib P/N 35-165050-84; L/H and R/H P/N's 35-165050-78 and -79, respectively.)

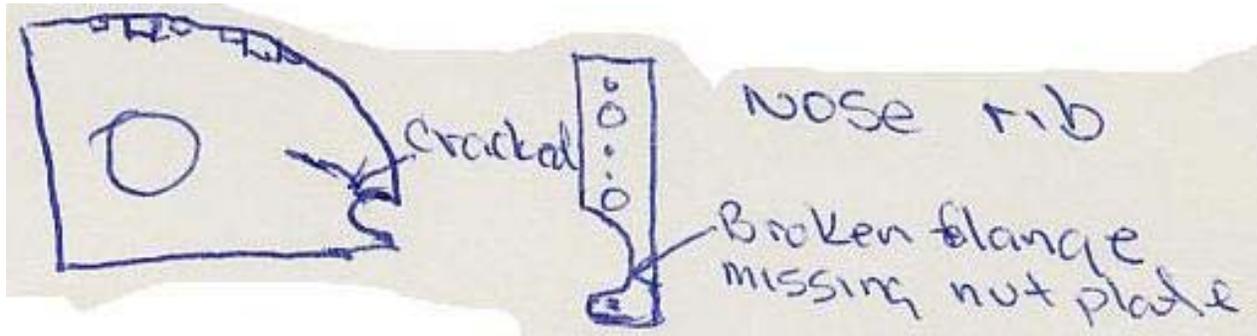
Beech: B95; Cracked Flap Leading Edge Nose Rib; ATA 5753

Inspection found the R/H flap rod attach bracket broken and the flap nose rib nut plate flange torn. Inspection of the L/H side found the (same) nose rib flange and web cracked.” (Flap Nose Rib P/N 35-165050-84; L/H and R/H Flap P/N’s 95-160000-601 and -602, respectively.)

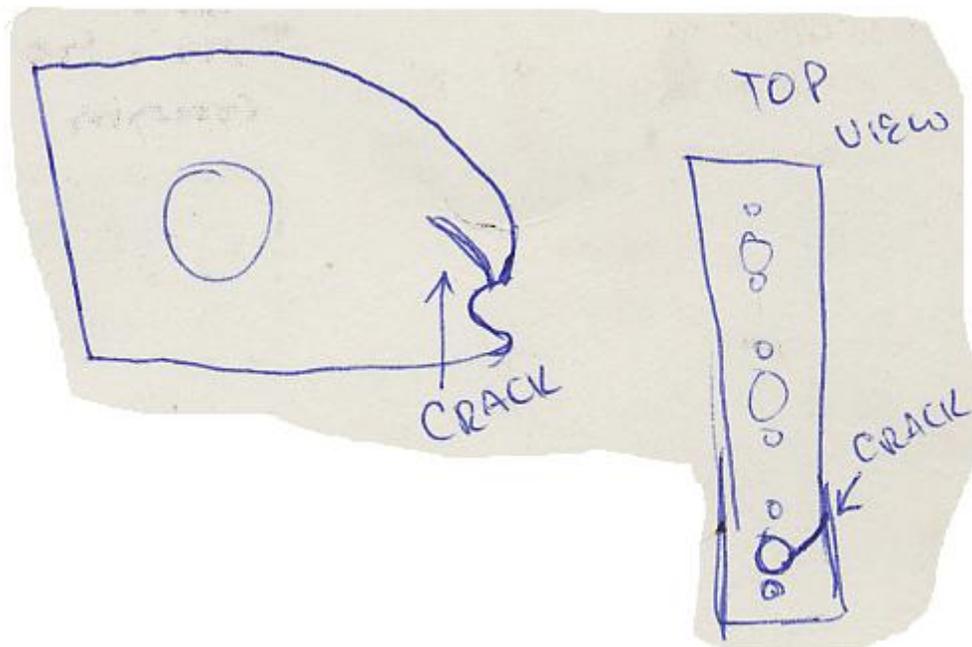
Beech: F33A; Cracked Leading Edge Nose Rib; ATA 5753

“An annual inspection found the R/H flap rod attach point rib cracked.” (Rib P/N 35-165050-84; Flap P/N 35-165050-606: both the flange and web were found to be cracked.)

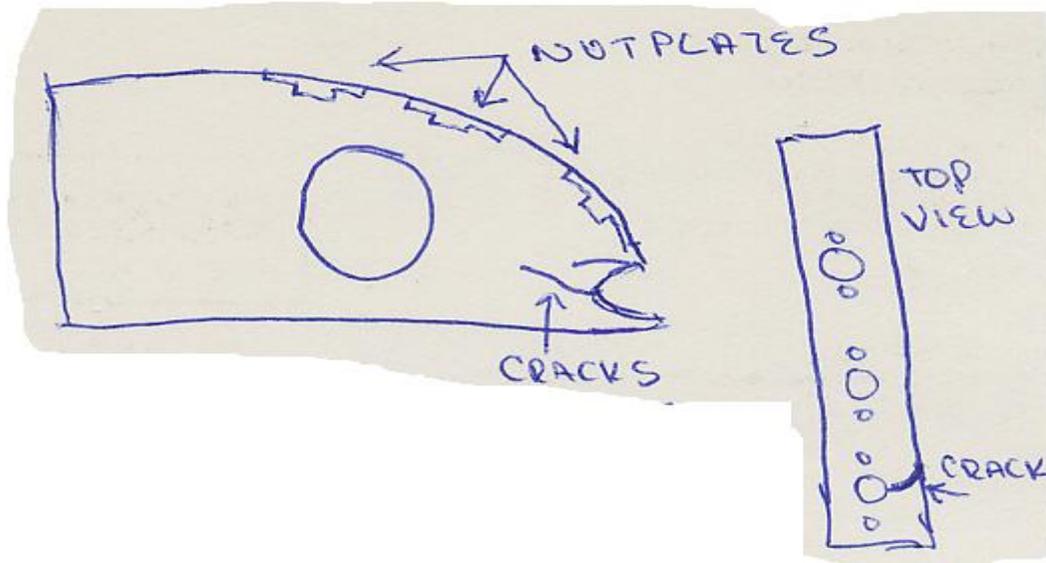
Beech: V35B; Cracked Flap Leading Edge Nose Rib; ATA 5753

“Annual inspection found the R/H flap rod attach point rib cracked.”(Rib P/N 35-165050-84; R/H flap P/N 35-165050-606)

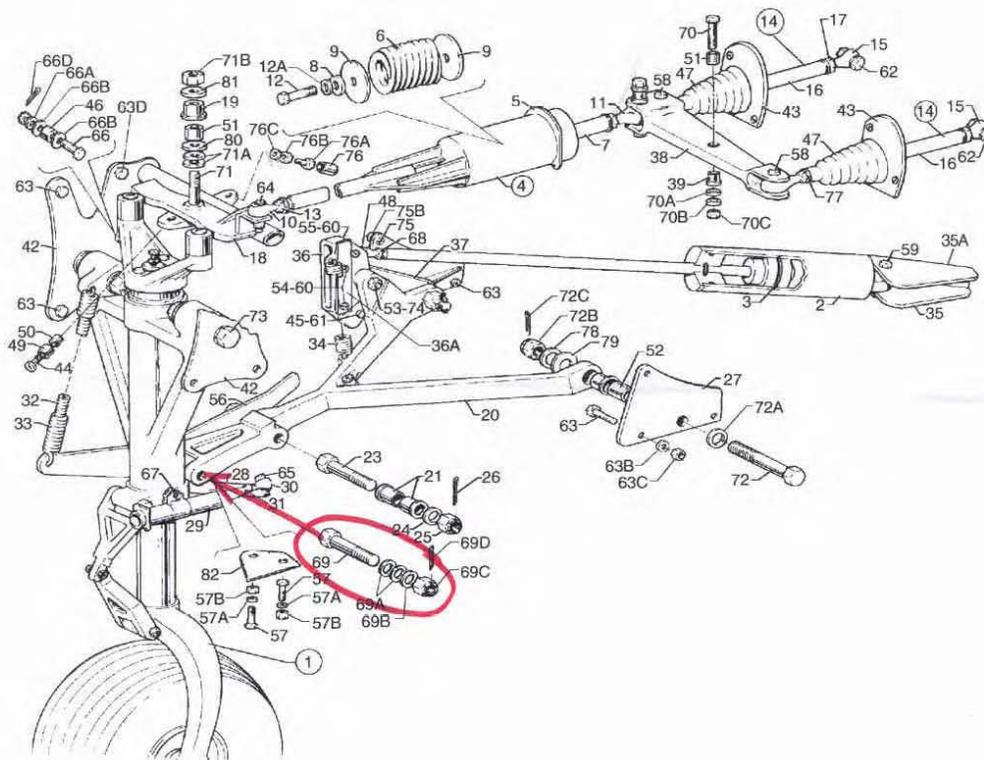
The NLG diagram from Piper's Airplane Parts Catalog is shown in Figure 1 for reference. Post failure, the fractured bolt, Figure item #69 was stuck in the NLG drag link assembly, Figure item #20, which is shown "as received" by FAST in Figures 2 & 3. The bolt was stuck in the drag link assembly due to the bending in the bolt shaft. The bolt could not be rotated in the assembly using finger force only. Another view of the fracture surface of the bolt is shown looking through the drag link assembly hole, Figure 4. There are significant fracture features visible at this level of magnification. There is a dark narrow band running through the center of the bolt from the 8 o'clock to 2 o'clock position. There is a semi-circle at the outer edge of the bolt at the 11 o'clock position, and on the opposite edge at the 4 o'clock position is a roughened edge. It was necessary for FAST personnel to cut the bolt so that the fracture surface could be examined in detail under the scanning electron microscope (SEM). The mating surface of the bolt was never found.

Figure 1. Figure item #69 is the bolt that failed. It is PN 400-191, an AN5-51 bolt.

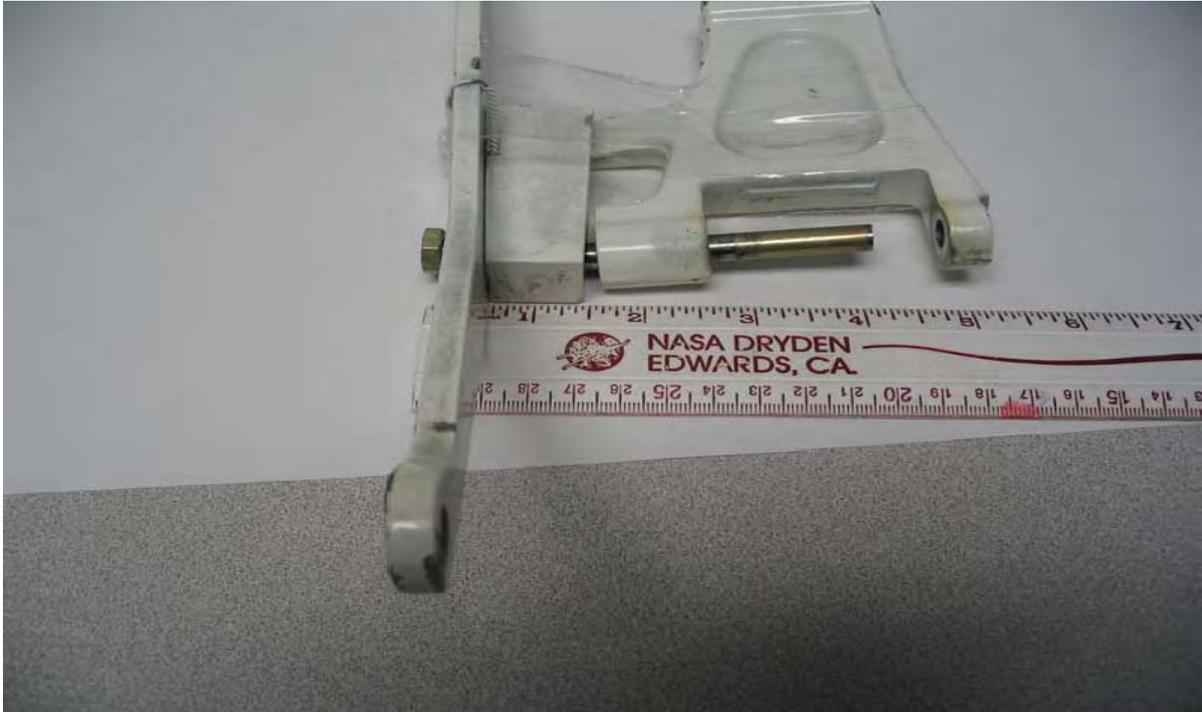
Figure 2. This photo shows the bolt still stuck in the drag link assembly, Figure item 20 in Figure 1.

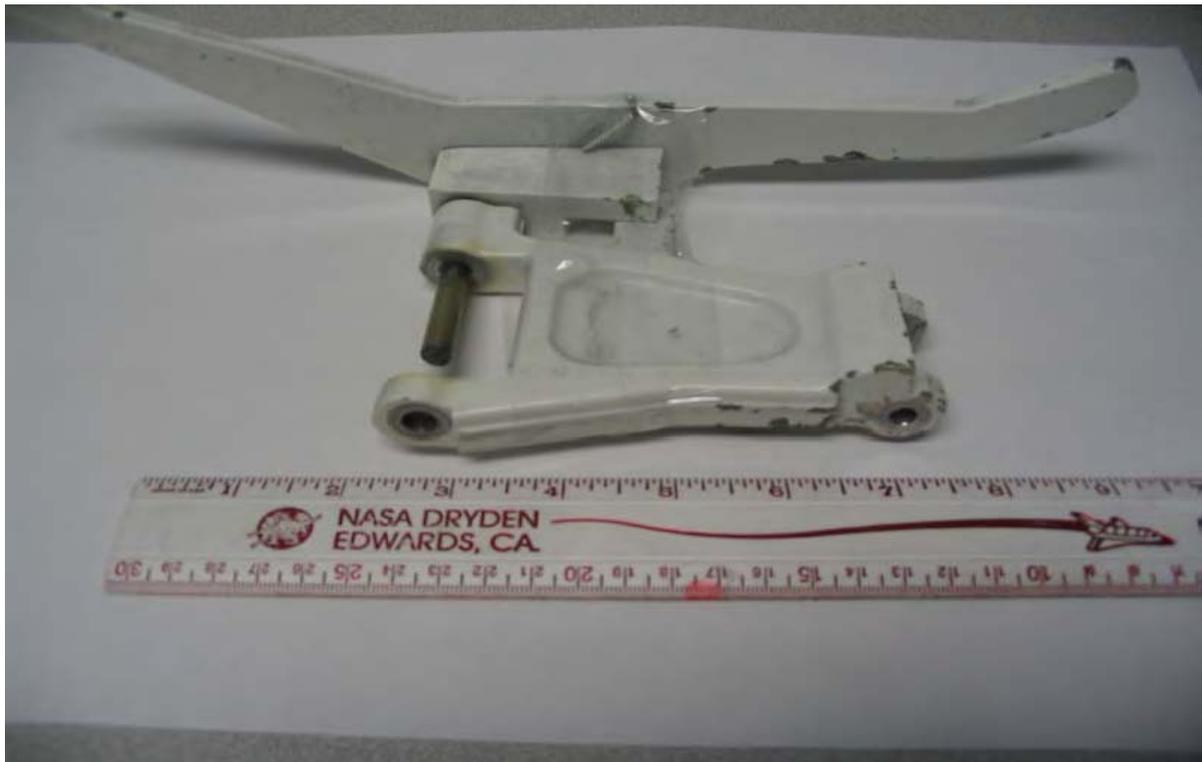
Figure 3. A side view of the bolt and drag assembly shown "as received."

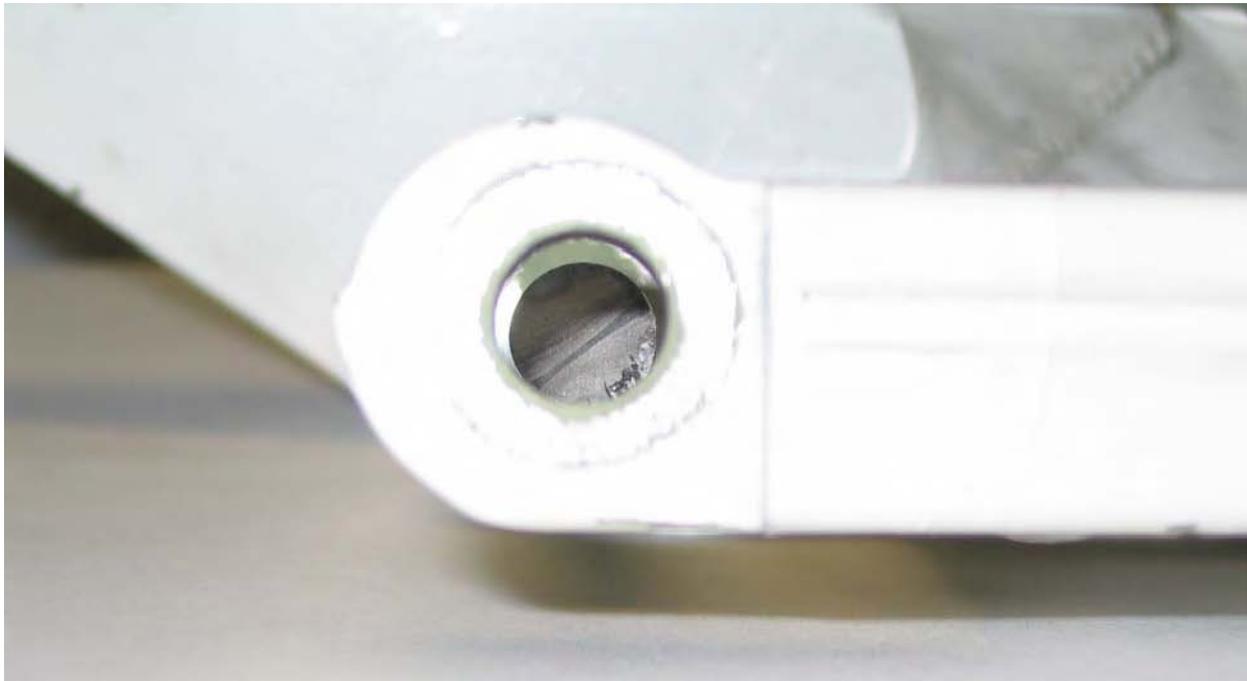
Figure 4. This photo looking through the drag link assembly hole reveals a dark narrow band running diagonally through the center of the bolt fracture surface from 8 o'clock to 2 o'clock. There is a semi-circle at the 11 o'clock position, and rough edge at the four o'clock position. These fracture features are shown in detail in subsequent photos.

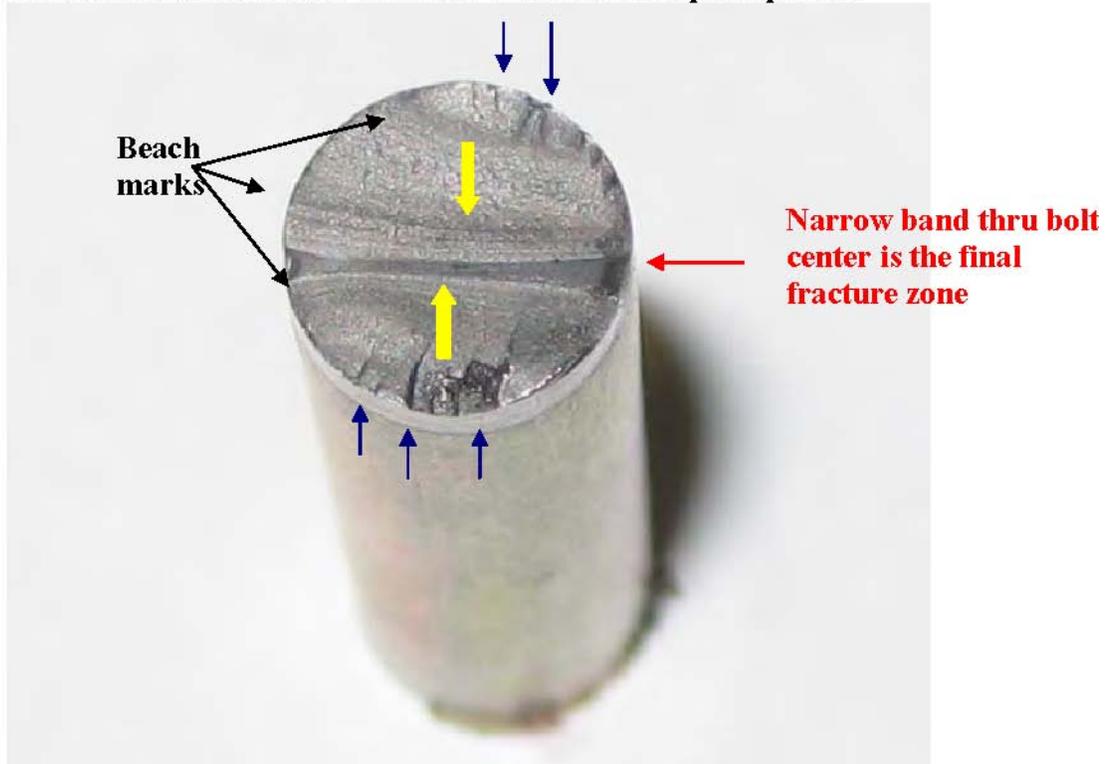
A macro photo of the bolt fracture surface after the shaft was cut by FAST personnel is shown in Figure 5. There are numerous fracture origins at both the top and bottom, indicated by the blue arrows, Figure 5. The yellow arrows indicate crack growth direction that progressed by fatigue from the fracture origins. The bolt finally failed instantaneously at the narrow dark zone traveling through the center of the bolt. A number of beach marks, which look like ripples in a pond emanating from the point where a thrown stone enters the water, emanate from the fracture origins at both the top and bottom edges. Each of these fracture features were examined in detail in the SEM.

Figure 5. This photo shows the bolt fracture surface with appropriate areas labeled. Blue arrows are fracture origins. Large yellow arrows indicate crack growth direction by fatigue.

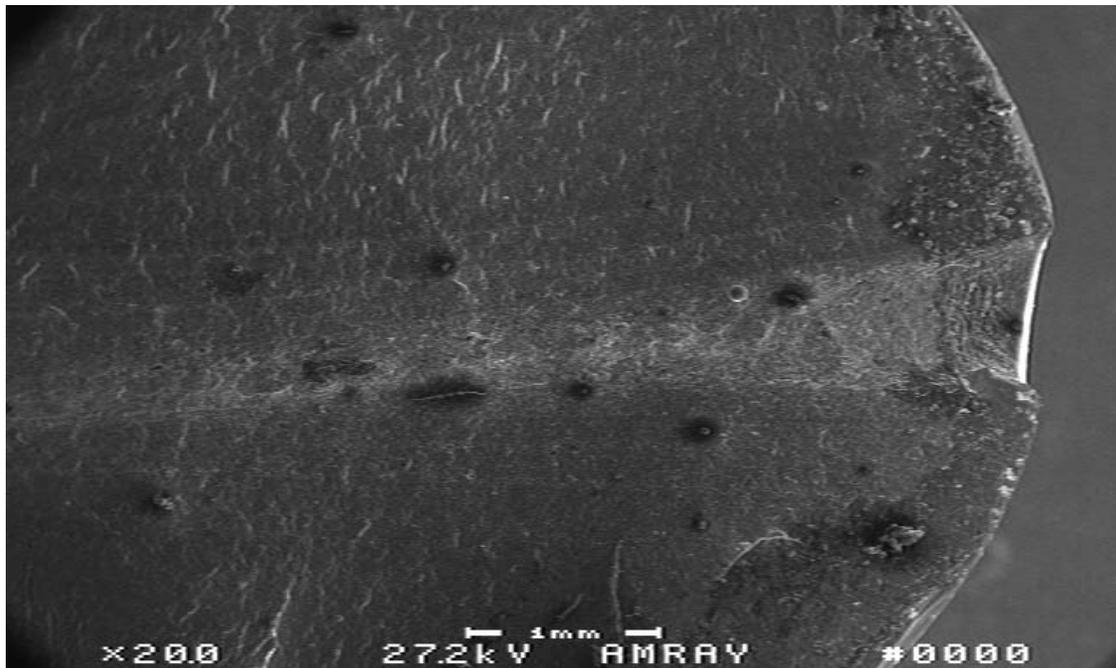
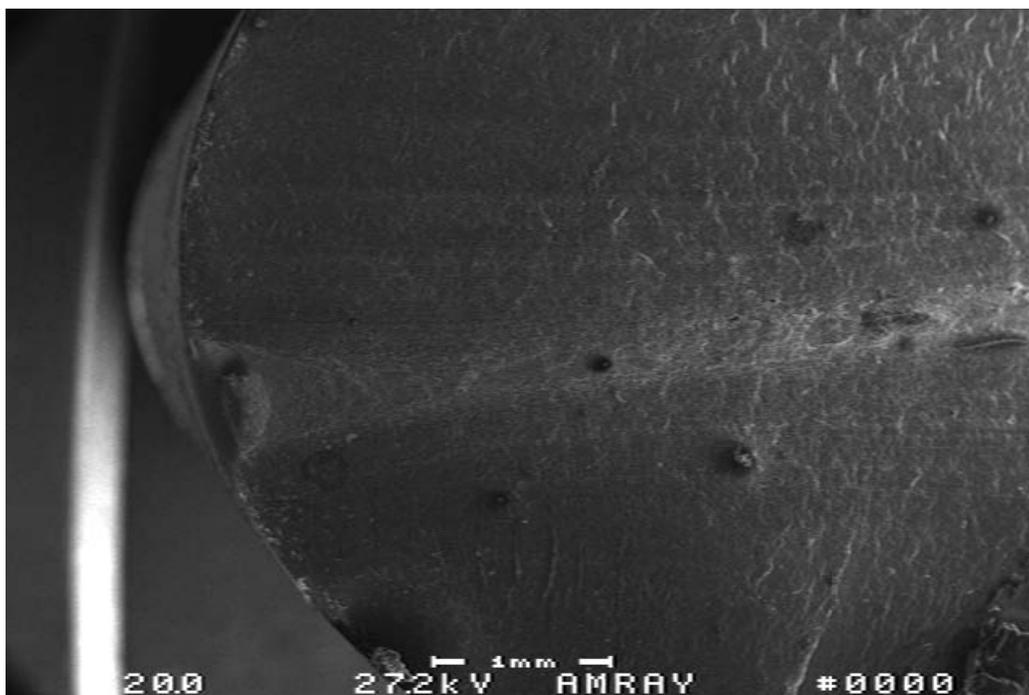
A 20X SEM photo of the narrow band running through the center of the bolt is shown in Figures 6 & 7. A number of beach marks can be seen in each of these photos. Notice that the marks above the center band are concaved upwards toward the fracture origin at the top. The beach marks below the center band are concaved downward toward the fracture origin at the bottom. Each beach mark represents crack growth stoppage from a landing and taxiing operation. The presence of numerous beach marks is proof that this bolt did not fail in one landing operation, but instead failed over many operations over a long period of time.

Figure 6. A 20X SEM photo of the right side of the narrow dark band running through the center of the bolt. Notice that the beach marks above the center band are concaved upwards, and those below the center band are concaved downwards.

Figure 7. A 20X SEM photo of the left side of the narrow center band. The description of the beach marks discussed in Figure 6 also applies here.

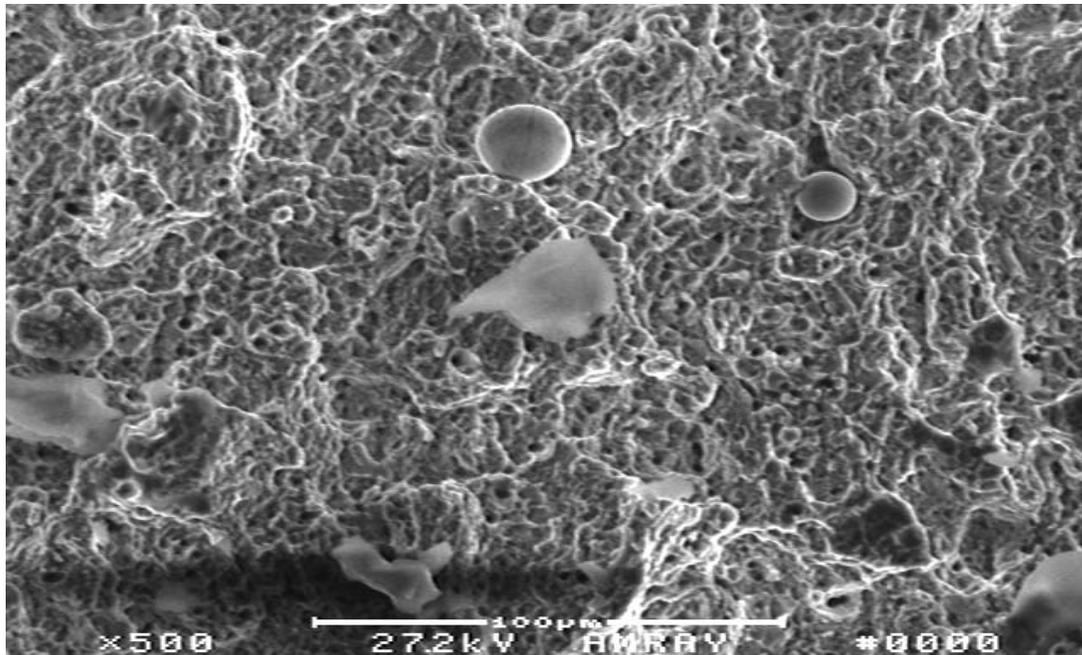
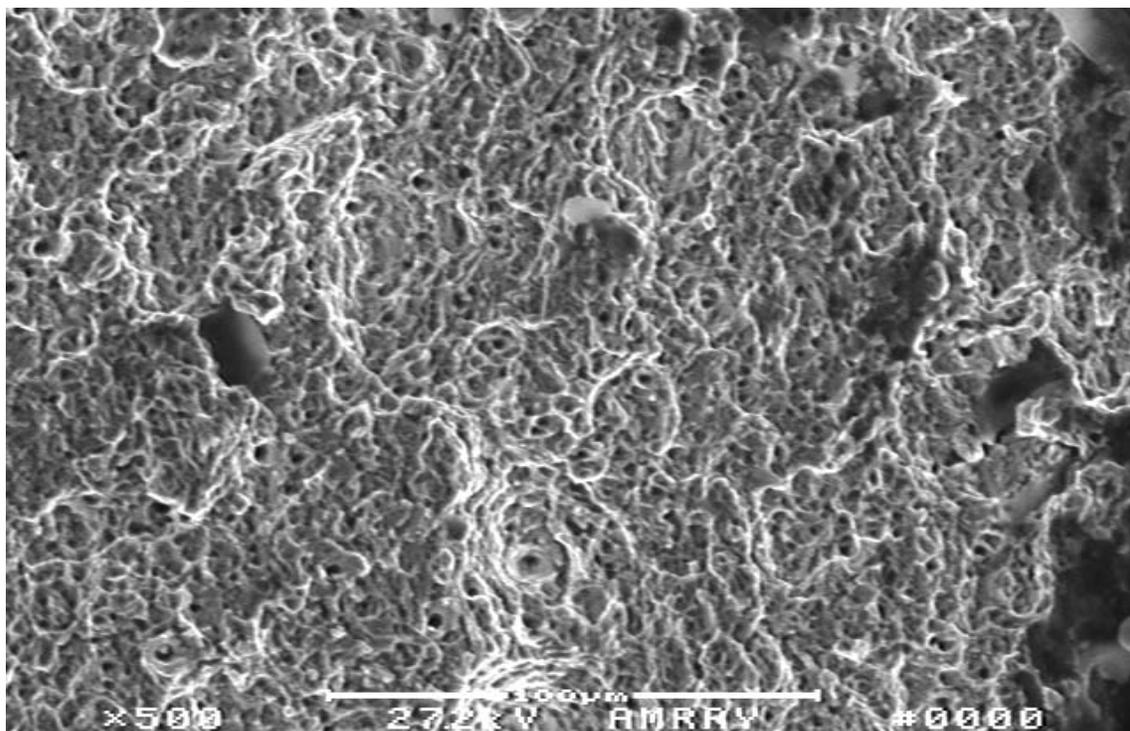
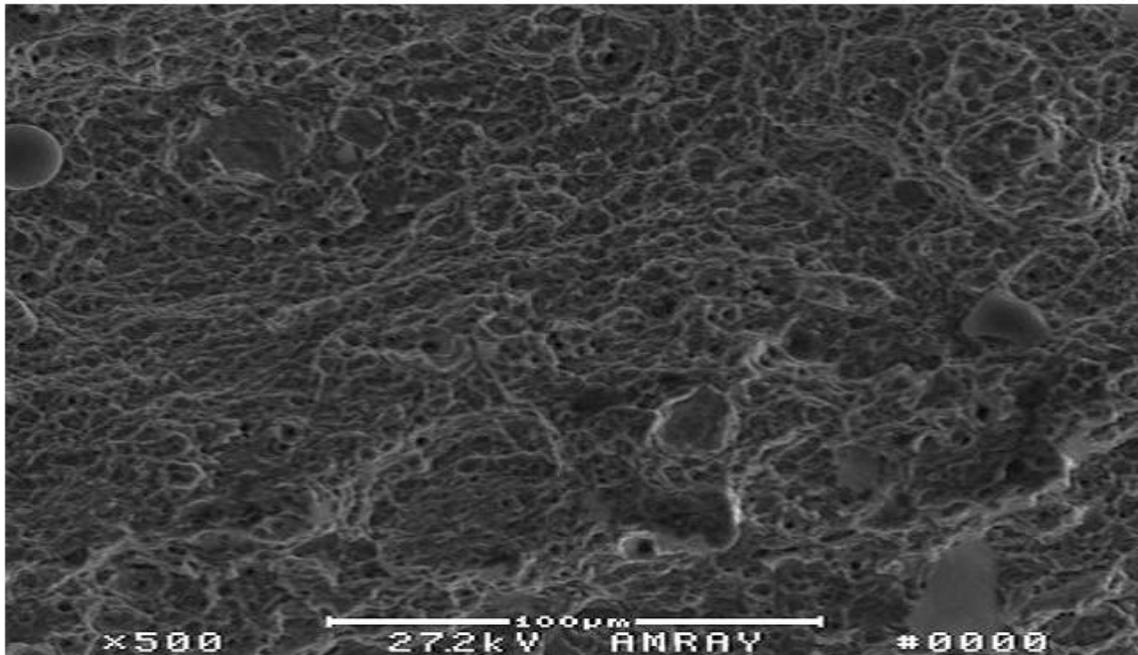
Higher SEM magnifications of the narrow center band are shown in the SEM photos, Figures 8 - 10. Each shows the characteristic ductile dimple fracture features of instantaneous overload. In other the words, this narrow center band represents the amount of metal holding the bolt together when it finally failed during the last gear retraction. There wasn't much.

Figure 8. A 500X SEM photo of the right side of the narrow band thru the center of the bolt reveals ductile dimple fracture features characteristic of instantaneous final fracture.

Figure 9. A 500X SEM photo of the center section of the narrow band reveals similar fracture features characteristic of overload.

Figure 10. A 500X SEM photo of the left side of the narrow band in the center of the bolt also reveals the ductile dimple fracture features characteristic of instantaneous overload.

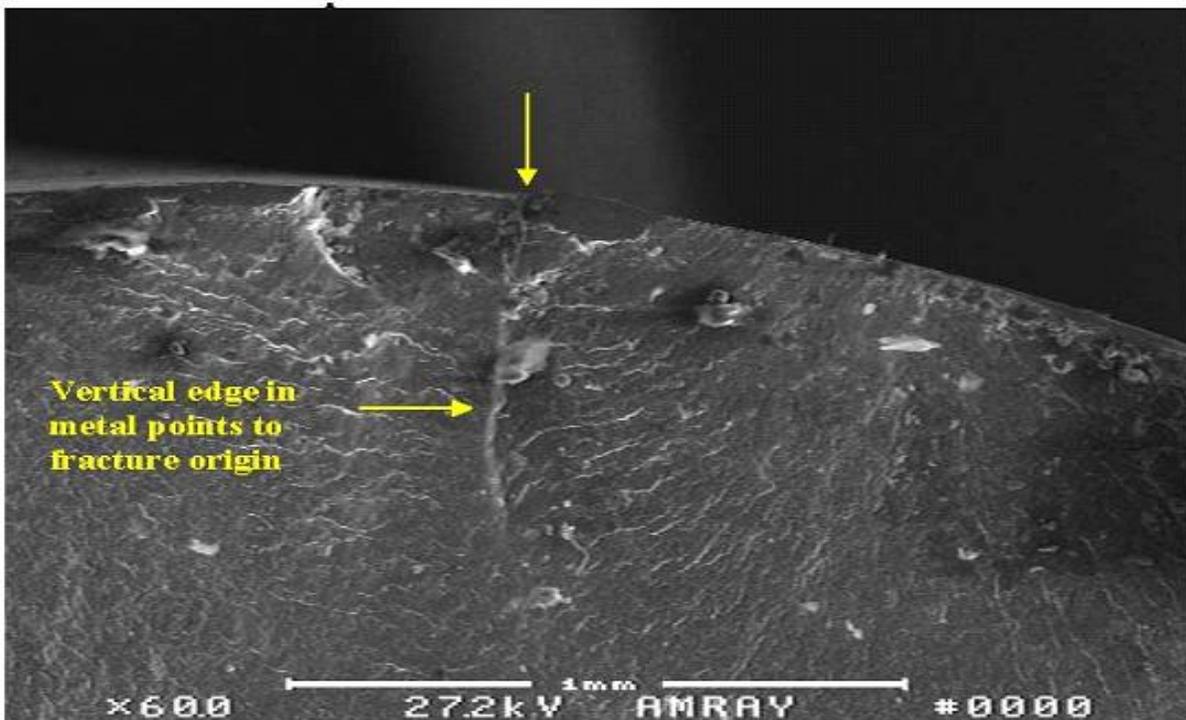
While the bolt finally failed in the narrow center band, the outer edges are where the fracture initiated. Progressive SEM magnification of the top edge shown in Figure 5, is shown in the SEM photos, Figures 11 - 13. The origin is indicated by the arrow in Figure 11. Notice that there is a vertical feature in the metal that also points to the origin. The 1000X SEM photo of the top origin shows a very smooth surface from rubbing of the mating surface of the bolt after the initial crack was formed. This photo also shows wear deformation at the outer edge of the bolt. A 1000X SEM photo of the area just below the origin reveals closely spaced parallel striations that are characteristic of fatigue crack growth, Figure 14. The striations are widened slightly

Figure 11. A 60X SEM photo showing the semi-circular shaped area at the bolt's top edge in figure 5. The origin is at the outer surface and indicated by the arrow. Note the vertical feature in the metal which also points to this edge.

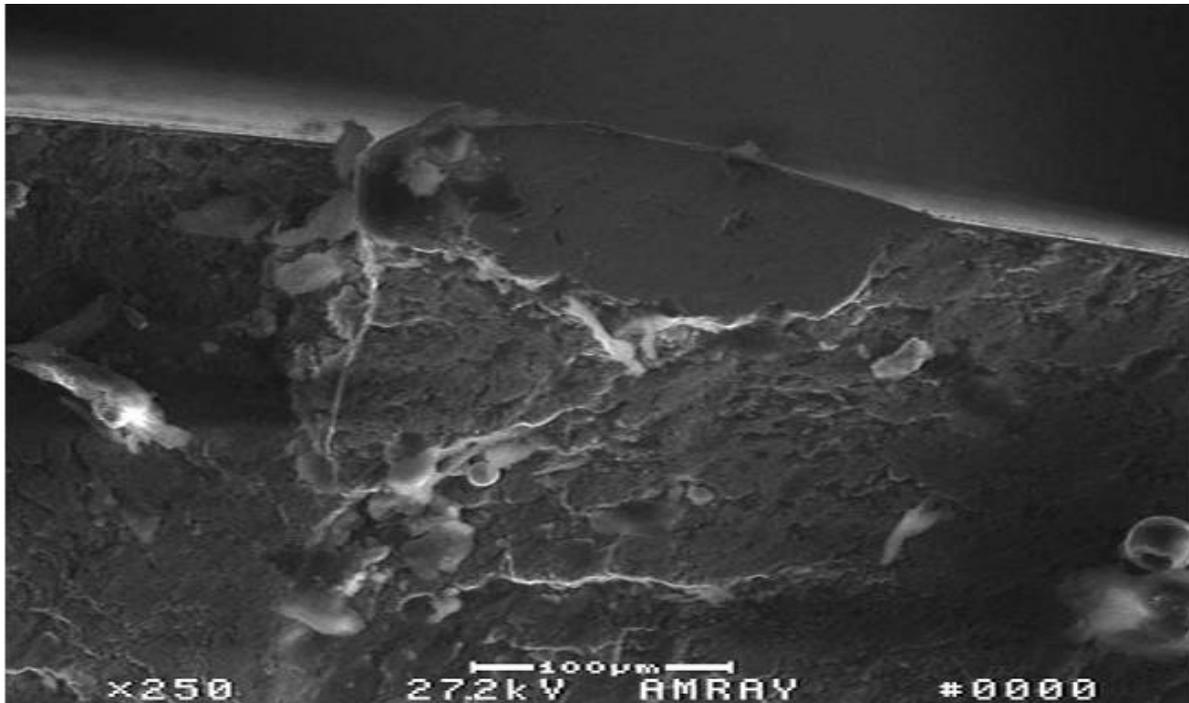
Figure 12. A 250X SEM photo of the origin shown in Figure 11.

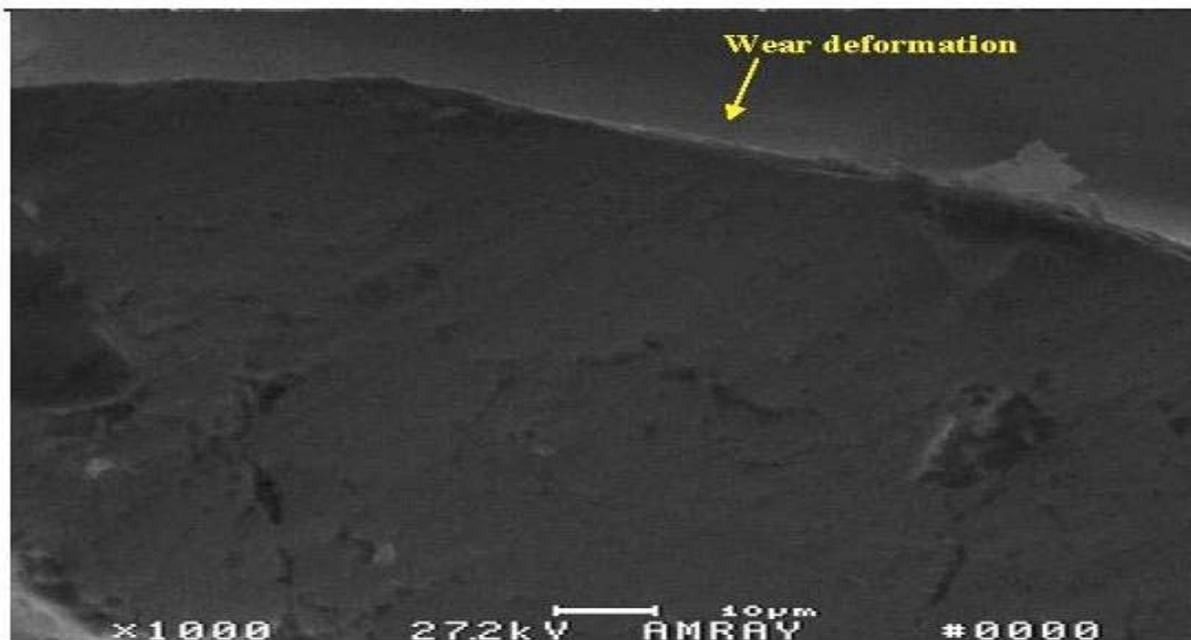
Figure 13. A 1000X SEM photo of the top fracture origin shows wear deformation at the outer edge. Notice the smooth fracture surface from rubbing with the mating surface after initial cracking.

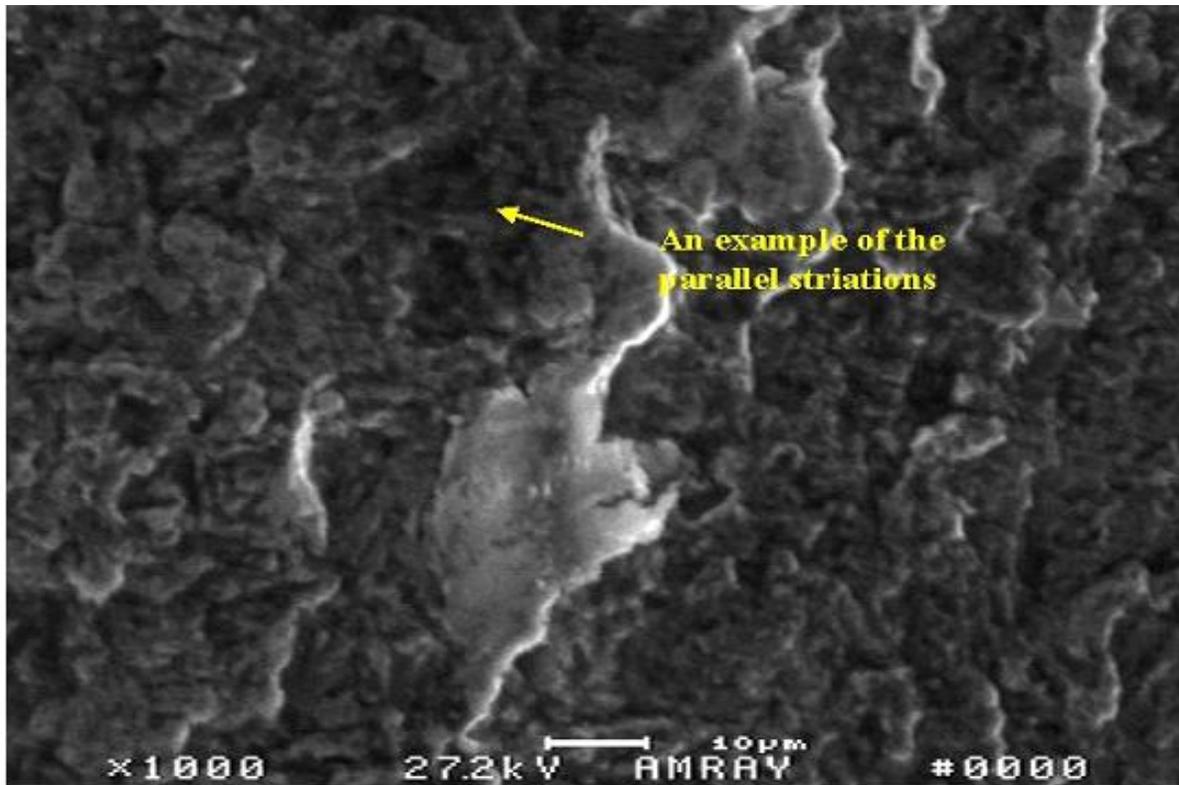
Figure 14. A 1000X SEM photo of an area just below the top origin shows parallel striations characteristic of fatigue crack growth.

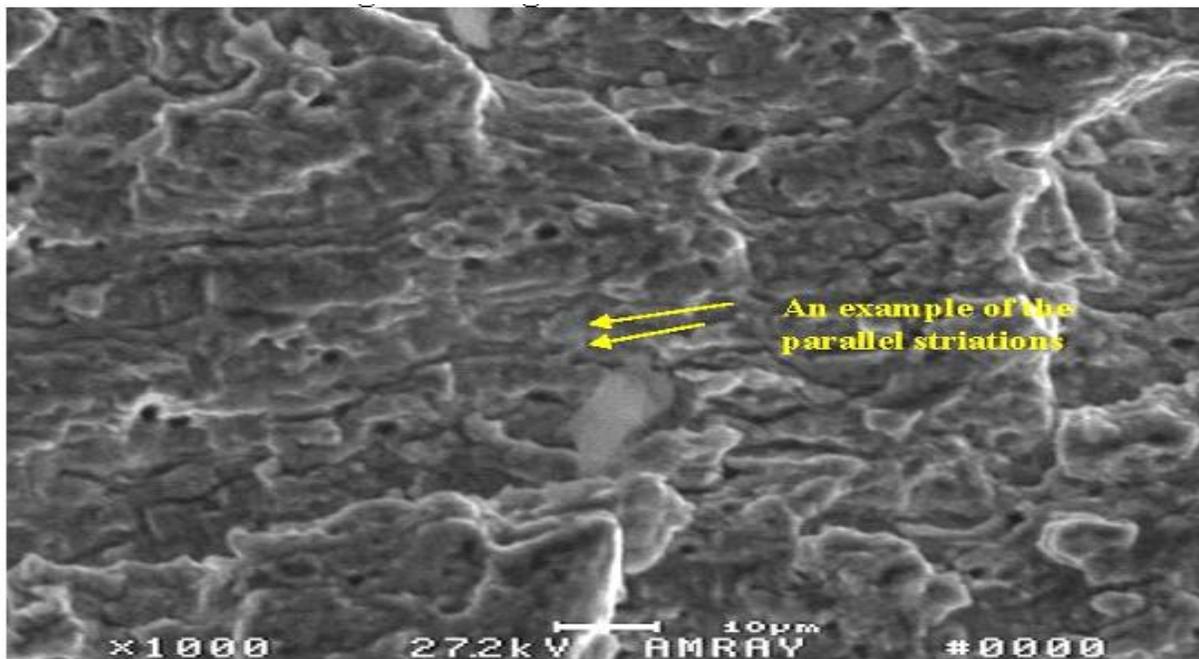
near the final fracture zone on the top half of the bolt due to less metal being able to sustain a landing and taxiing operation, Figure 15. So crack growth was accelerating.

Figure 15. A 1000X SEM photo of an area below the top origin and above the final fracture at the center of the bolt shows parallel striations characteristic of fatigue crack growth. Crack growth direction runs from top to bottom.

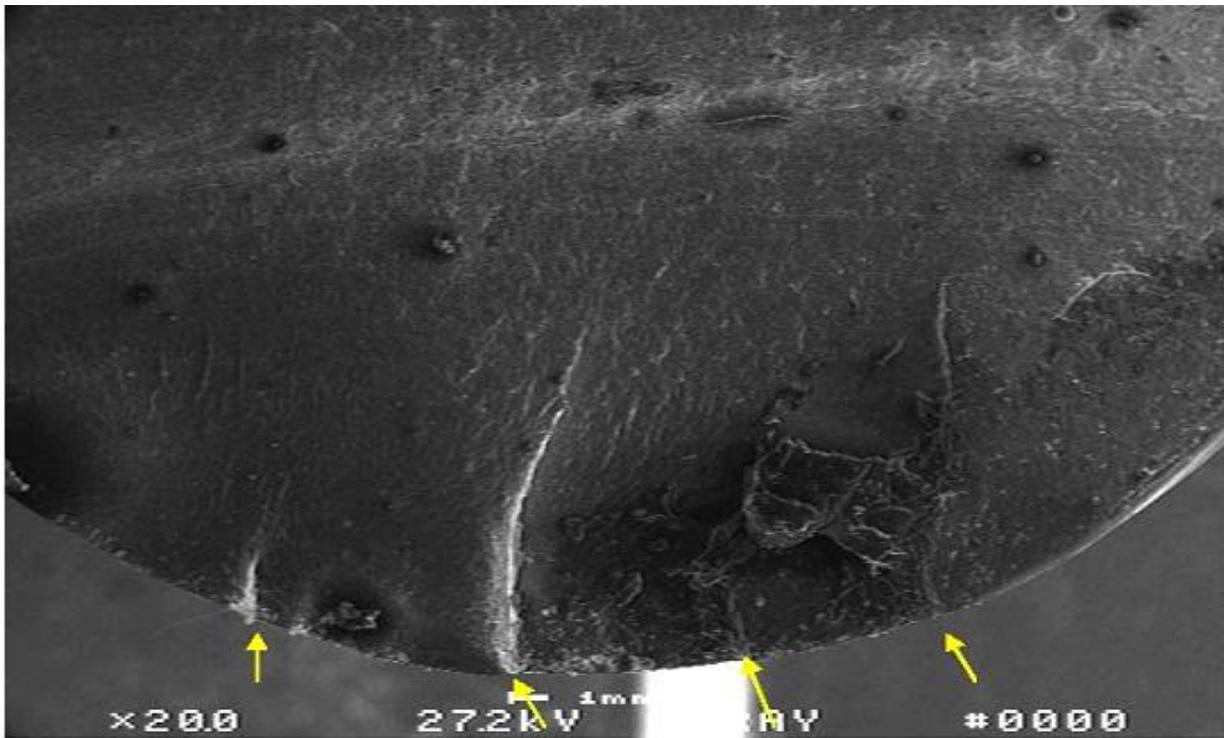
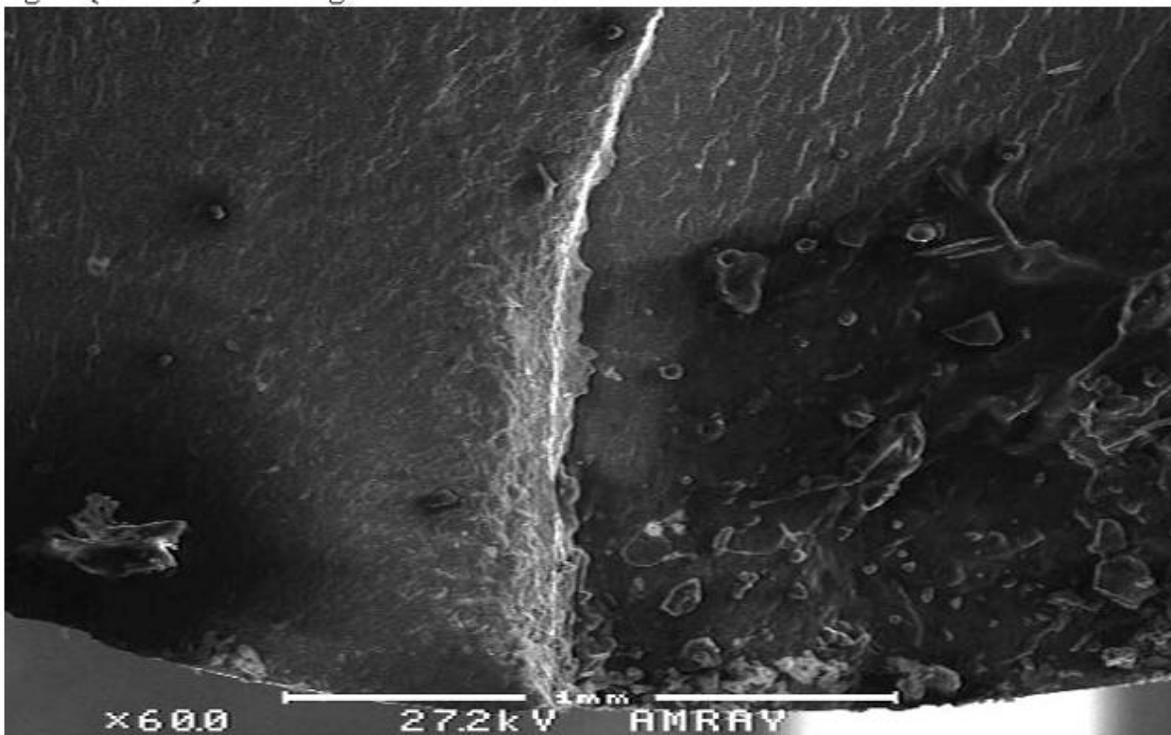
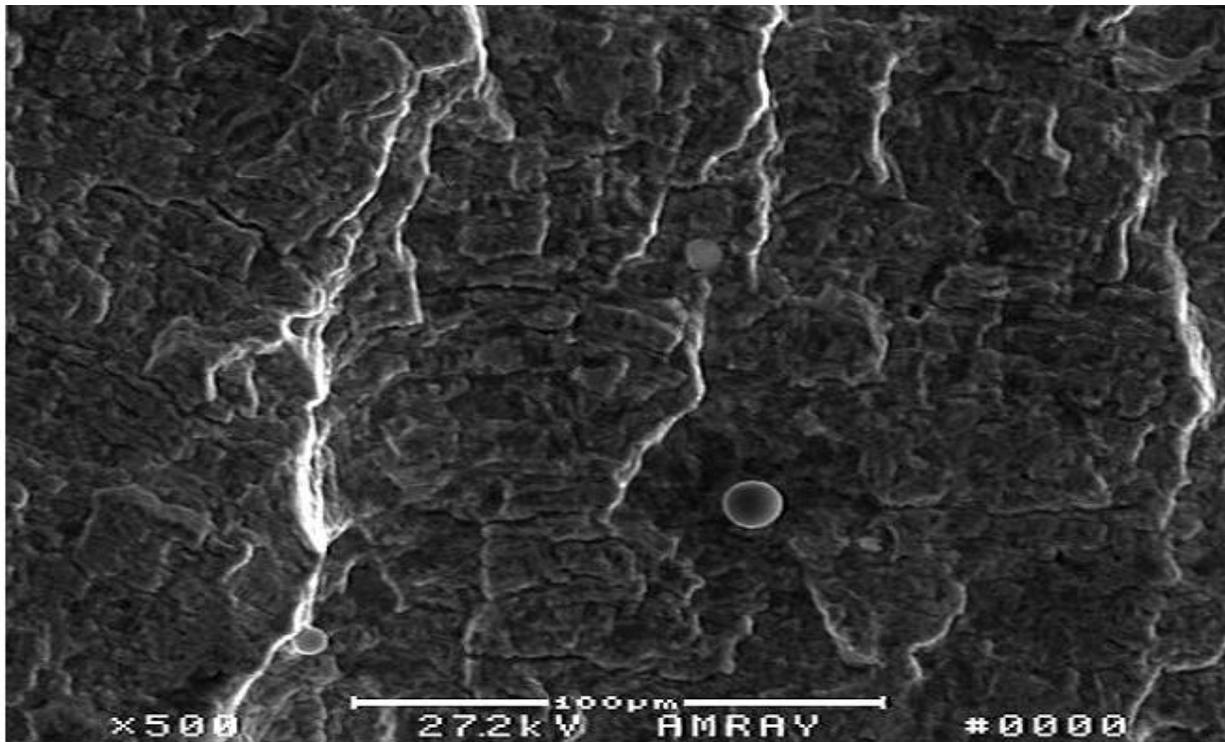
Similar fracture features are shown in the SEM photos for the bottom of the bolt, Figures 16 - 18. A 20X SEM photo of the bottom edge reveals multiple fracture origins at the outer edge. A 60X SEM photo of the origin at the 6 o'clock position is shown in Figure 17. A 500X SEM photo of the fracture surface just above this origin reveals fatigue crack growth features, Figure 18.

Figure 16. A 20X SEM photo of the bottom edge of the bolt from Figure 5 shows multiple origins (arrows) at the edge.

Figure 17. A 60X SEM photo of the bottom origin at the 6 o'clock position as shown in Figure 16.

Figure 18. A 500X SEM photo of the area just above the origin shown in Figure 17 reveals fatigue fracture features.

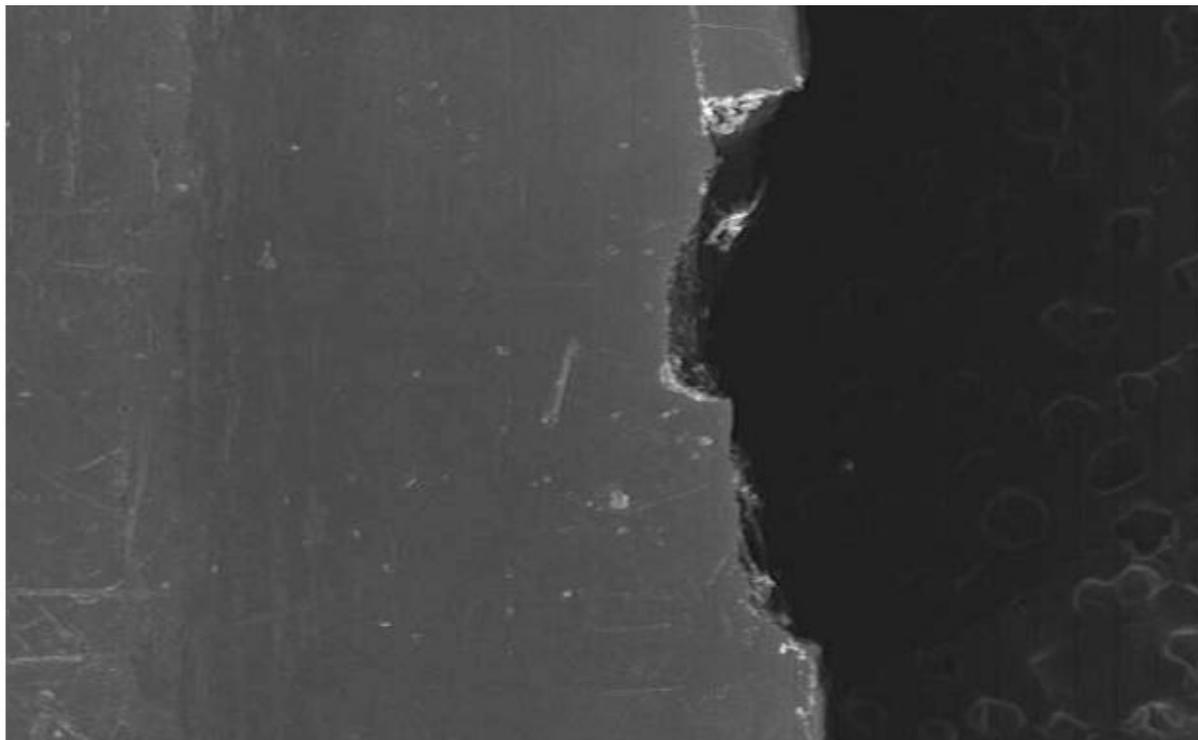
A side profile of the bolt at the 6 o'clock edge shown in Figure 5 is shown in the 30X SEM photo, Figure 19. Progressive SEM magnifications of this area show a crack in the edge and wear, Figures 20 – 22. These photos reveal that the source of the stress concentration from which crack growth proceeded by fatigue is from wear with in the mating NLG bushing. The wear is very close to the edge of the bushing. Notice the gold color is worn from the bolt right at the edge of the fracture, Figure 23.

Figure 19. A 30X SEM photo of the side of the bolt at the 6 o'clock area from Figure 5 shows some wear and a crack.

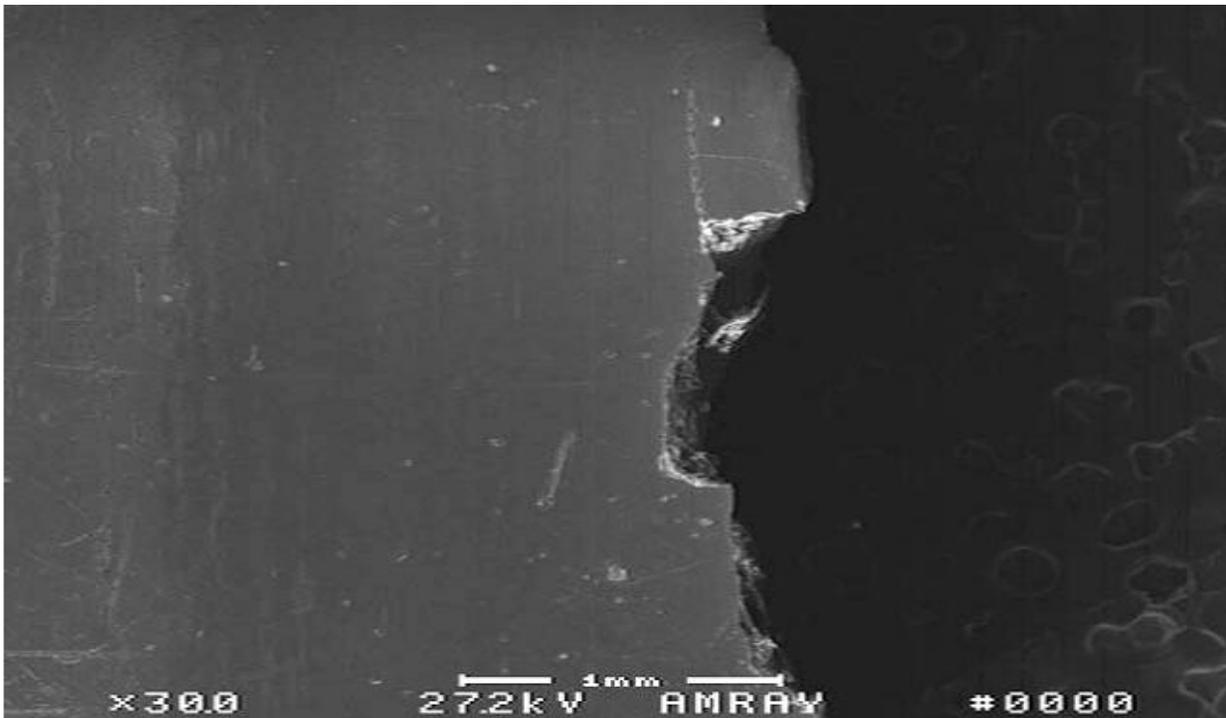
Figure 20. A 30X SEM photo of the side at the 6 o'clock fracture origin shows a crack on the surface.

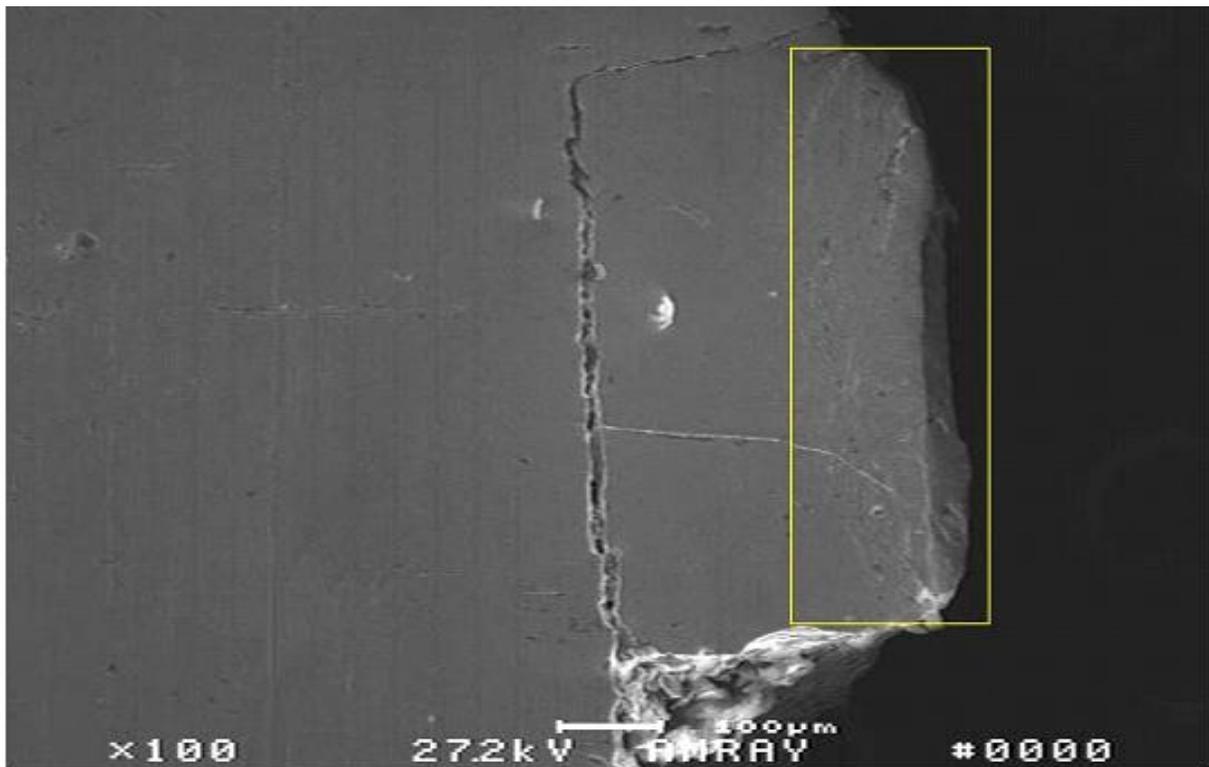
Figure 21. A 100X SEM photo of the cracked area from Figure 20. Notice the wear area outlined by the box.

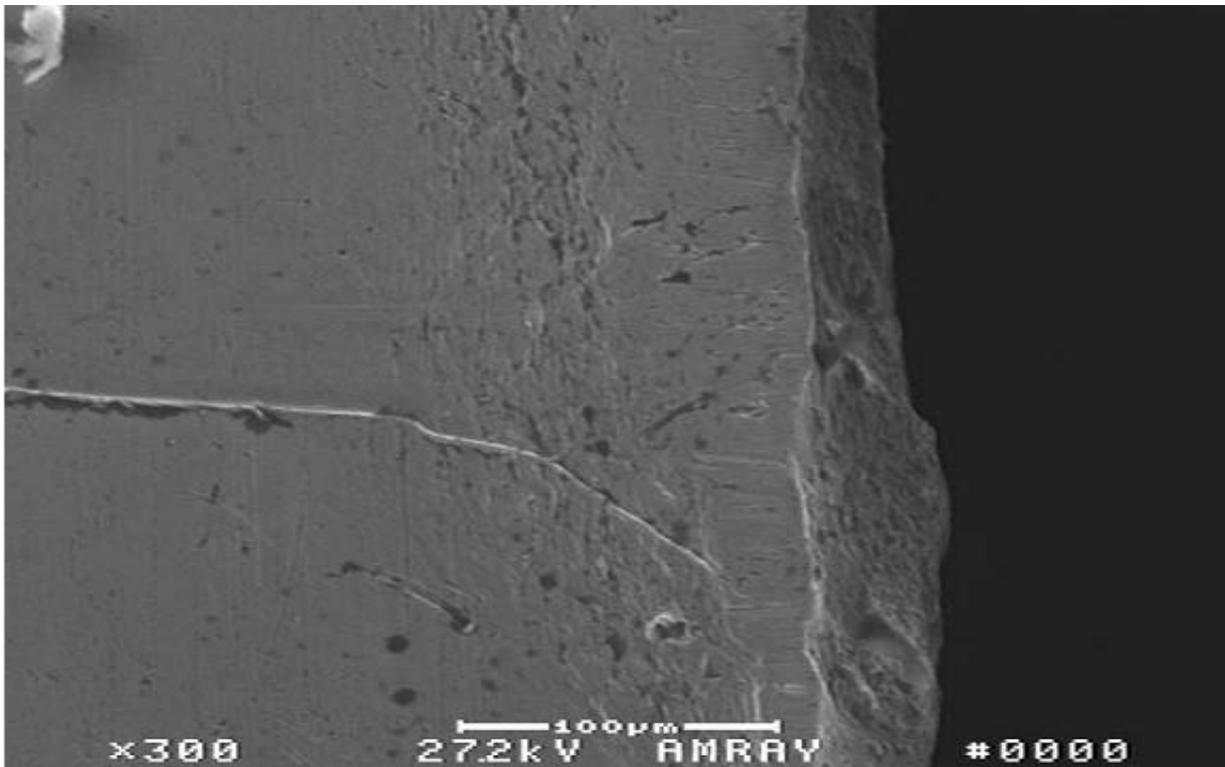
Figure 22. A 300X SEM photo of the outlined area in Figure 21 shows the wear.
